ENVIRONMENTAL IMPACT OF MINING, EROSION AND SEDIMENTATION IN SRI LANKA

C. B. DISSANAYAKE and M. S. RUPASINGHE

Institute of Fundamental Studies, Hantana Road, Kandy, Sri Lanka

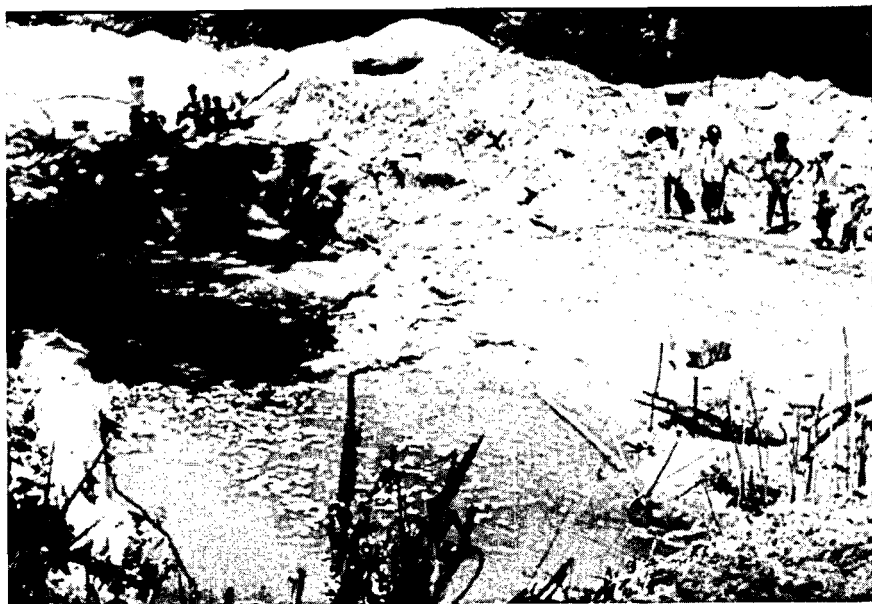
FIGURE 6 Sedimentation of water bodies caused by gem mining.

In a detailed study of the environmental impact of gem mining in the Ratnapura district, the main gem producing region of Sri Lanka, de Silva^[6] has made quantitative estimates on the soil extracted from a gem mine (Figure 4). It has also been found that nearly half the legal miners and probably all illegal miners leave their soil heaps around the mines (Figure 5). Further, the unfilled gem pits form ideal breeding grounds for mosquitoes and studies have indeed revealed an increase in the incidence of malaria in the gem mining regions. The soil heaps around the gem pits are easily transported with the rains causing damage to the nearby lands and flora. The rains and floodwater also carry the sand, silt and clay to the nearby streams, rivers and low-lying areas or rice fields causing problems of sedimentation. The deposition of sediments apart from blocking streams and canals also destroys fish-spawning grounds. Heavy sediment deposition raises the stream beds thereby reducing the capacity of rivers to absorb flood waters (Figure 6).

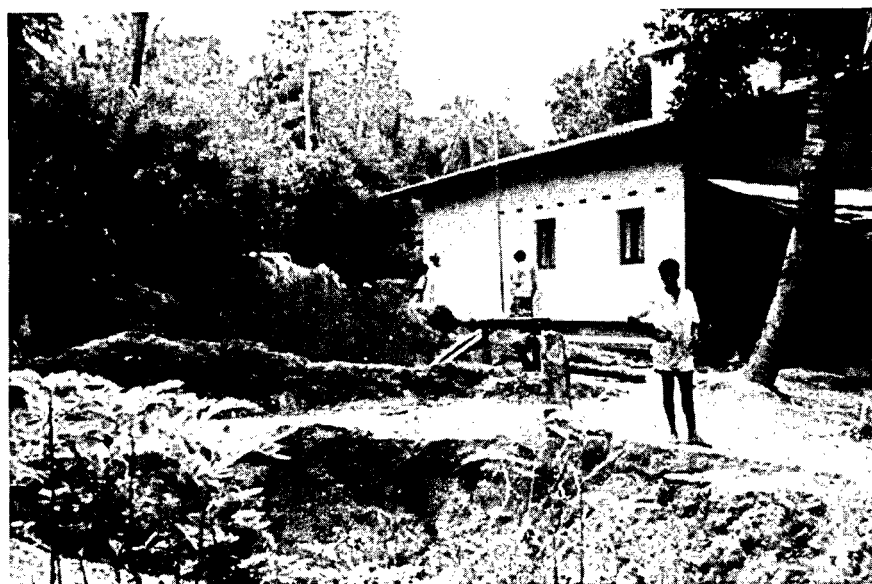
FIGURE 7 Damage to man-made structures by gem mining.

Gem mining by tunnelling under roads, houses, canals and culverts cause extensive damage to man-made structures (Figure 7). In spite of the existence of environmental laws pertaining to gem mining, such activities still persist in several parts of Sri Lanka.
